FLOOR DEPRESSION DETAIL  
AT DOOR AND CEILING  
WITH QUARRY TILE

FD. 1A

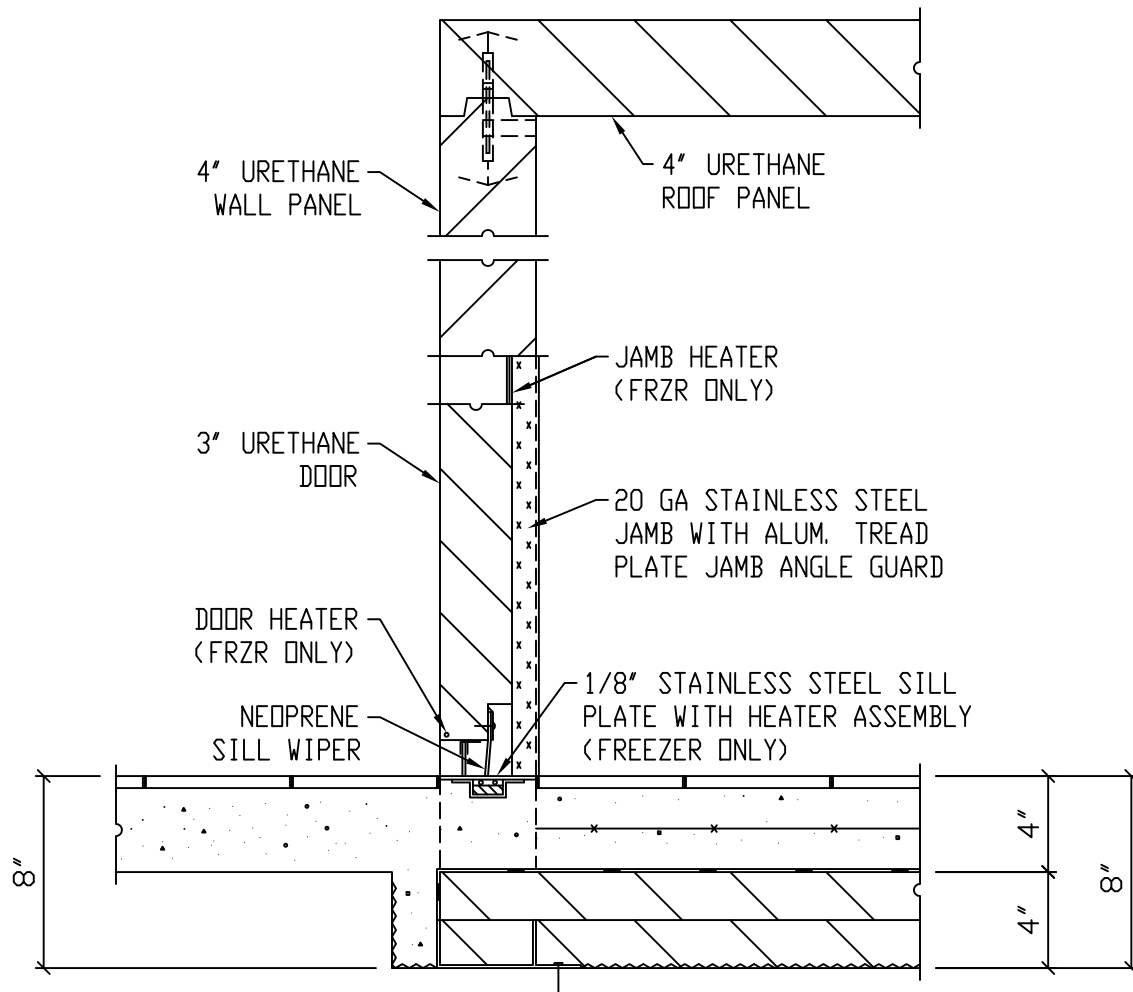
SECTION  
(@ DOOR) (FD)
